Supplemental Information for 021-511 or 120694 Angle Drive (Speedometer Cable to Gearbox) Austin Healey BN4-BJ8, MGB 63 on, TR'S 63 on

TECHNICAL SERVICE BULLETIN

Re: Right Angled Speedometer Adaptor Failures

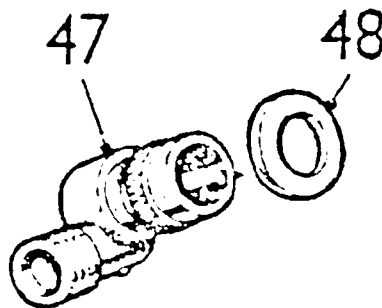
WASHER 3H 550

Repeated failures of the above have, in many instances, been caused by Washer-Adaptor to gearbox Part Number 3H 550 not being fitted when a new right angled drive adaptor is installed.

This causes an excessive end load and premature failure of the right angled drive pinion.

IMPORTANT! When fitting the angle drive, fit a 324-720 or 3H550 washer as shown on the next page.
