1 Supplemental Information & Instructions
2 for
3 **635-675 or 150380Z Switch, Exterior Lighting**
4 **TR6 73-76, SPITFIRE 75-80, GT6**

Recall Campaign Bulletin

RECALL CAMPAIGN A444
TRIUMPH HEADLAMP SWITCH

1969 - 1973 GT6
1969 - 1974 Spitfire
1973 - 1976 TR6

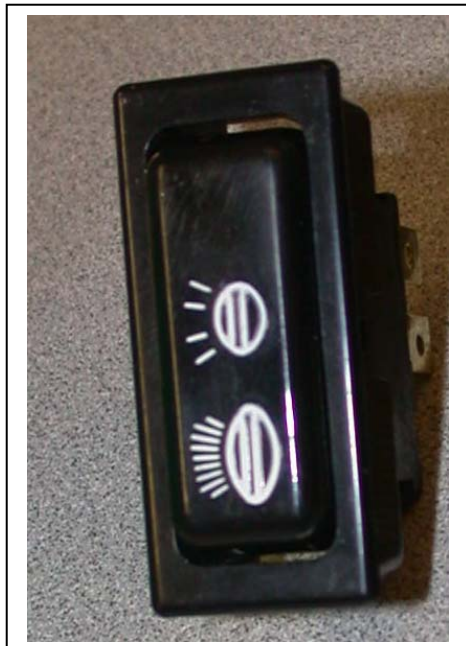
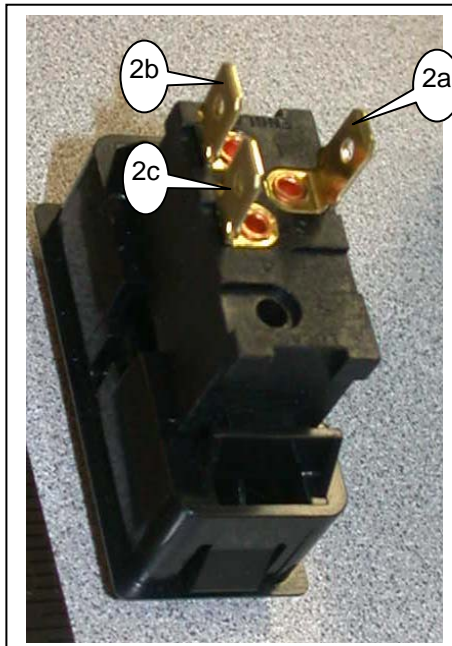
Hole in dash for
Clear Hooter
Switch

24 Triumph bought lighting switches from several suppliers. The switches made by "Clear Hooter" were used
25 on the GT6 from 69-73, Spitfire from 69-74, and on the 73-76 TR6. They were terrible and frequently
26 failed, leaving the vehicle without headlights, parking lights, or both. Triumph launched a recall campaign
27 on June 6, 1978, and many of the affected vehicles had the "Clear Hooter" switch replaced with a Lucas
28 switch. Because the "Clear Hooter" switch was physically smaller than the replacement Lucas switch, the
29 hole in the dash (7/16" x 1 3/8") needed to be enlarged. British Leyland made up kits for the dealers to
30 facilitate the exchange. Unlike the Spitfire and GT6, the TR6 had a metal dash, and they made up a
31 special punch & die tool to enlarge the hole for the switch. Today, none of the kits are available, and of
32 course neither is the tool for the TR6. If you find that the switch we supplied will not fit the hole in your

33 dash, you will need to enlarge the hole. Luckily the hole in the TR6 dash only needs to be enlarged about
34 1/16", and you can do that with a hand file. The Lucas switch we offer for these applications is very similar
35 to the switch included in the factory kit. Because the original Recall Notice has the recommended factory
36 procedures for fitting the replacement switch (and it makes interesting reading!) we have appended the
37 original seven page document to this information sheet.
