**Supplemental Information & Instructions
for
360-010 TACH REDUCTION GEARBOX
MG T SERIES**

Instruction Sheet Moss 360-010 September 2009

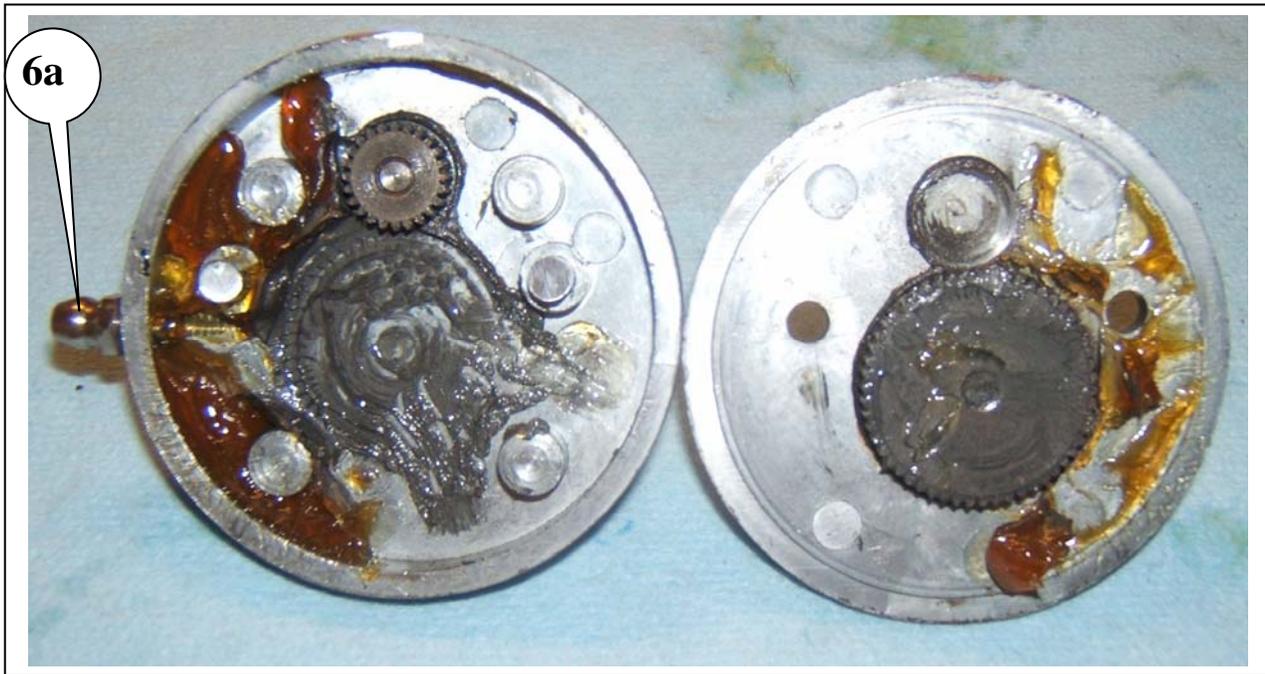
The gearbox (360-010 or 27H210) sold by Moss is a high quality reproduction of the original item. When they are assembled, the manufacturer injects grease inside the case through the grease nipple (6a).

Over time the grease will thicken, and when you first try and turn the shaft (5c) you will feel some resistance. It may even seem that the gearbox is “frozen”, or locked up solid. Having inspected and disassembled quite a few of these, we know that the stiffness is the grease.

Once broken loose, the shaft will turn, and it gets easier as the grease gets spread around the inside of the housing. If you wish, you can use an electric drill to spin the shaft for a minute. Then try it by hand. You will find the shaft rotates easily and smoothly.

This is why we recommend that you check the tach reduction gearbox as an assembly out of the car to make sure the cable spins freely, and that it drives the tach reduction gearbox smoothly. Once you are satisfied that the gear reduction box is operating as it should. Please review the information we have included on page two for solutions to potential installation problems prior to installing this unit.

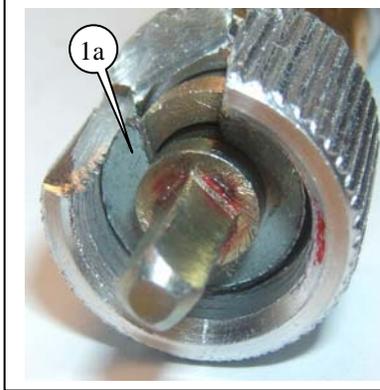
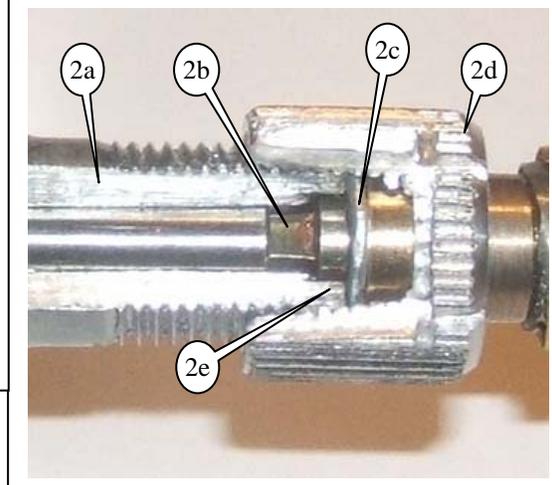
Found only with the OE style cable. The cable manufacturer currently uses a circlip (1a) to retain the inner cable in the housing. When attached to the tach reduction gearbox (2a), the circlip (2c) bottoms out against the end of the tach reduction gearbox (2e) when the nut on the cable (2d) is tightened. The cable is locked in place and it cannot rotate.
