Oil Seal Conversion Kit Fitting Instructions

Part Number:	MGS108321 & MGS108322
Description:	Oil Seal Conversion Kit, Rear Crankshaft, lip Type Seal
Applications:	MGS108321 - Morris Minor & Sprite & Midget 1098cc (10CC) MGS108322 - Morris Minor & Sprite & Midget 948cc & 1098cc (10CG)

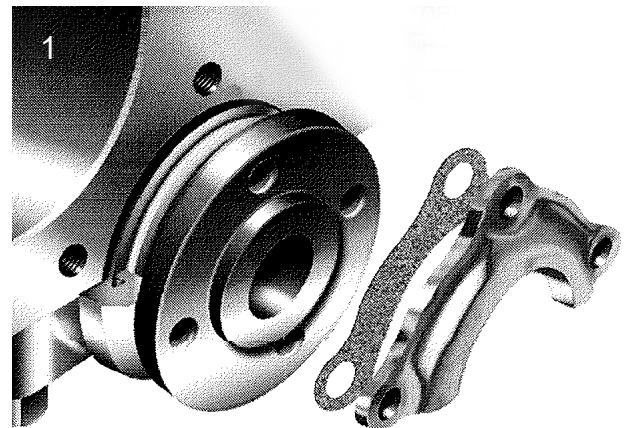
Remove the flywheel, back plate, sump and the half round cover above the rear main bearing cap. Carefully clean up the rear block face adjacent to the main bearing cap (image 1), removing all traces of the gasket and burrs etc. The new oil seal will run on the outer horizontal edge of the flywheel mounting flange on the crank (image 3). This will need careful cleaning up, it must be checked for damage and carefully polished smooth with wire wool or fine emery. If it is really badly scored then a maximum of .25mm can be machined from the edge to provide a good surface; this should only be done in extreme cases, keeping the metal removal to a bare minimum. Please do make sure the face the seal is to run on is smooth. The ideal flywheel flange diameter should be 82.62mm for the 948 and 1098 Minor engines and 89mm for the 1098 MG engines with the 10CC engine prefix. Extremes should not exceed .5mm in either direction.

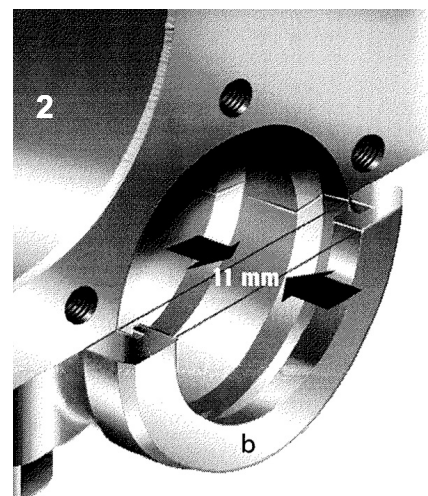
Remove the main bearing cap, take out the shell and clean it all thoroughly. Looking at the main bearing cap you will see that the end face (image 2) is not flat, it having been left "as cast" from manufacture; consequently the height of this end face from the block will be uneven and variable. The triangular alloy packing piece supplied fits above the main bearing cap, against the block and is exactly 11 mm thick. To ensure an oil tight seal in this area and for the oil seal to run square to the

flange, the end face of the main bearing cap must be be machined both flat and square to the block and at 11mm from it (image 3).

This is critical to the sealing of this kit, I deliberately repeat here that when the alloy triangular part of this kit is screwed to the block its outer face must be level with the end face "B" (image 2) of the main bearing cap throughout its length and in all planes. This part of the fitting process is the longest and requires a good deal of accuracy as it is essential to the complete sealing of the kit to the block. In the very unlikely event of the height already being less than 11mm, you can remove up to 1mm from the alloy triangular part to compensate.

Remove the alloy triangular part again and apply a coating of sealant to its mating faces where it meets the block and the main bearing cap, but do not use a gasket. Secure it to the block ensuring it sits snugly against the main bearing cap faces (image 3). Refit the engine backplate now.

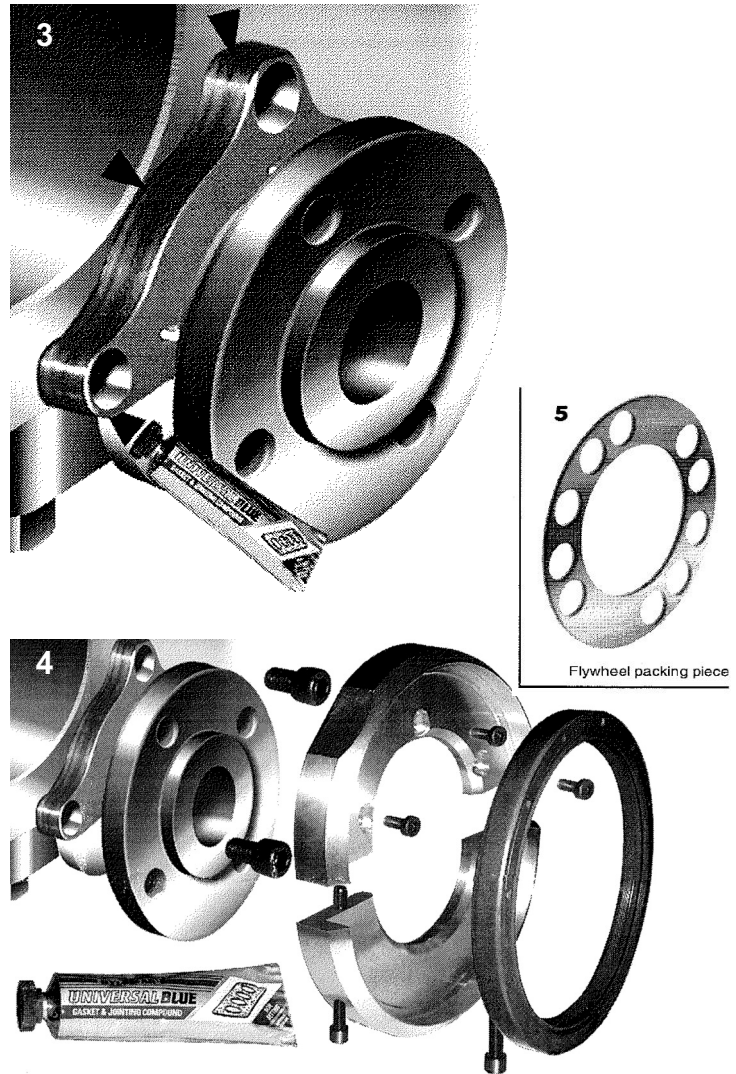
Separate the two halves of the circular carrier by unscrewing the two 4mm socket screws in its periphery. The upper half is held to the alloy triangular part by the three 4mm x 10 screws, access to which is through the bolt holes in the flywheel mounting flange. You will notice that the three fixing holes in the upper half are slotted, this will enable the seal to be centralised on the flange prior to final tightening (image 4).

Put a coating of sealant around the back of the upper half and assemble to the alloy triangular part with the small screws, but leave them slightly loose to allow a little movement of the carrier. The oil seal has a double lip, pack some grease between them before fitting, also lightly pack the inside of the seal (where the spring is). Use sealant around all the joint faces including where the seal sits inside the carrier, lubricate the flywheel flange with oil and slip the seal over the crank into the upper half. The seal is fitted in the normal way; cavity inwards and the flat face visible from the outside.

Put more sealant around the lower half (anywhere there is a joint face!) and slide it into position behind the already fitted seal. Insert the two long screws in the rim and tighten to about 31bs pressure. The seal should now have centralised on the crank and the three smaller screws can now be tightened also. Apply some more sealant around the joint between the lower half and the main bearing cap just for good measure and allow the sealant to cure for at least 8 hours before running the engine. The metal ring supplied is a flywheel packing piece (figure 5), designed to keep the flywheel away from the seal face, and must be fitted between the flywheel and the crank. Rotate the packer until four of the eight holes line up with the bolt holes.
