Supplemental Information for 021-511 or 120694 Angle Drive (Speedometer Cable to Gearbox) Austin Healey BN4-BJ8, MGB 63 on, TR'S 63 on

TECHNICAL SERVICE BULLETIN

Re: Right Angled Speedometer Adaptor Failures

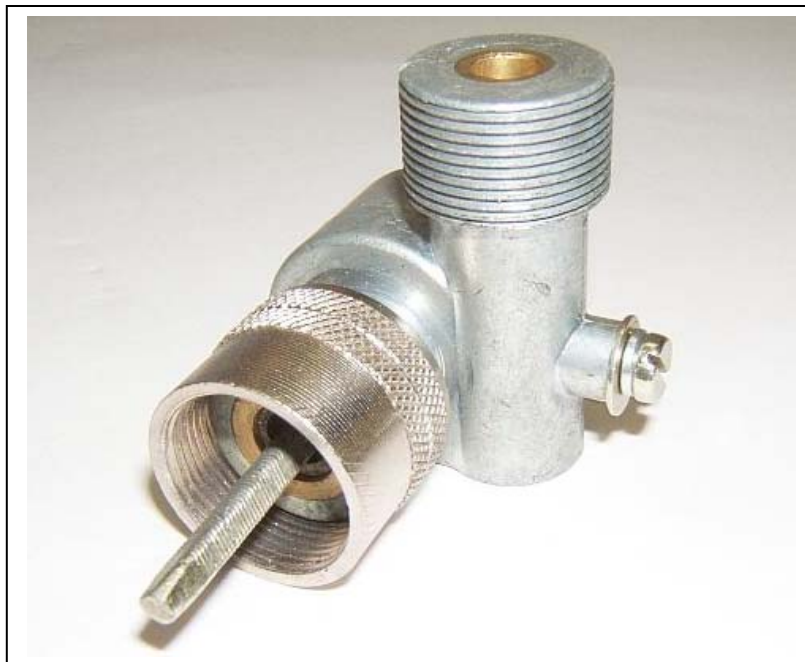
This speedometer angle drive was fitted to many British cars where there was insufficient room to run the speedometer cable directly into the gearbox. The original angle drives quickly developed a reputation for being prone to failure. This resulted in a thorough investigation that in the end resulted in the Technical Service Bulletin (TSB) of February 29, 1968. The TSB (copy on the next page) explains that the 324-720 or 3H550 "washer-adaptor to gearbox" **must** be fitted with the angle drive. If the washer is left out, the end load on the angle drive will be excessive and it will fail. When we first offered our reproduction of the 120694 angle drive, we included information in the catalog and with the part regarding the necessity for the washer.

We also assumed (incorrectly, as it turned out) that the angle drive being replaced would probably have the necessary washer, which could be transferred to the new angle drive. Despite our best efforts to get the word out, a significant number of new angle drives were fitted without the washer. It became apparent that the best thing to do would be to simply include the 324-720 or 3H550 washer with the angle drive, and explain why it was needed.

IMPORTANT! When fitting the angle drive, fit a 324-720 or 3H550 washer as shown on the next page.
