1 Supplemental Information & Instructions
2 for
3 **635-675 or 150380Z Switch, Exterior Lighting**
4 **TR6 73-76, SPITFIRE 75-80, GT6**

Recall Campaign Bulletin

RECALL CAMPAIGN A444
TRIUMPH HEADLAMP SWITCH

1969 - 1973 GT6
1969 - 1974 Spitfire
1973 - 1976 TR6

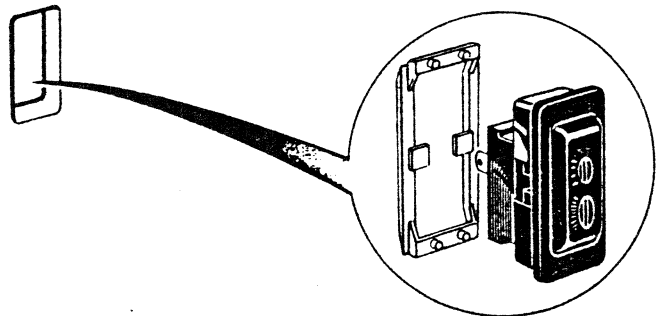
ILL. E - LUCAS SWITCH

8. Note terminal numbers on Lucas switch connect wire 1 thru 3 to the corresponding terminals (see illustration E).
9. Install plastic dash center panel.

CAUTION: DO NOT LOOSEN, CONTINUE TIGHTENING UNTIL TOOL BECOMES FREE IN DASH. TWO CLICKS SHOULD BE HEARD.
 - F. Remove complete tool by pushing through cut hole in dash.
6. Note terminal numbers on Lucas switch, (see illustration E).
Gaining access through speedometer opening, slip retainer clip on the three headlight wires, then pass wires through opening for switch. Connect wire 1 thru 3 to the corresponding terminals.
7. Insert switch into dash, hold switch in position and through speedometer opening secure retainer clip to switch (see illustration D).
8. Connect battery ground terminal and test lights. Position 1 (first click), parking lights -- position 2 (second click), headlights. After test, remove battery ground terminal.
9. Install speedometer.
10. Connect battery ground terminal.
