Supplemental Information for

356-110 Harness with Cloth braid wrap, wires with PCV Insulation, and 357-030 Harness with Cloth Braid Wrap, wires with Lacquer Braid insulation

This wiring harness is for non-EXU MG TCs to C 7379, which did not have factory turn signals. This harness is made with all the wiring necessary to install turn signals and it is therefore unique, and it does not match any factory wiring diagram we are aware of. Use of this harness is practical ONLY if you are replacing the entire harness in the course of a restoration.

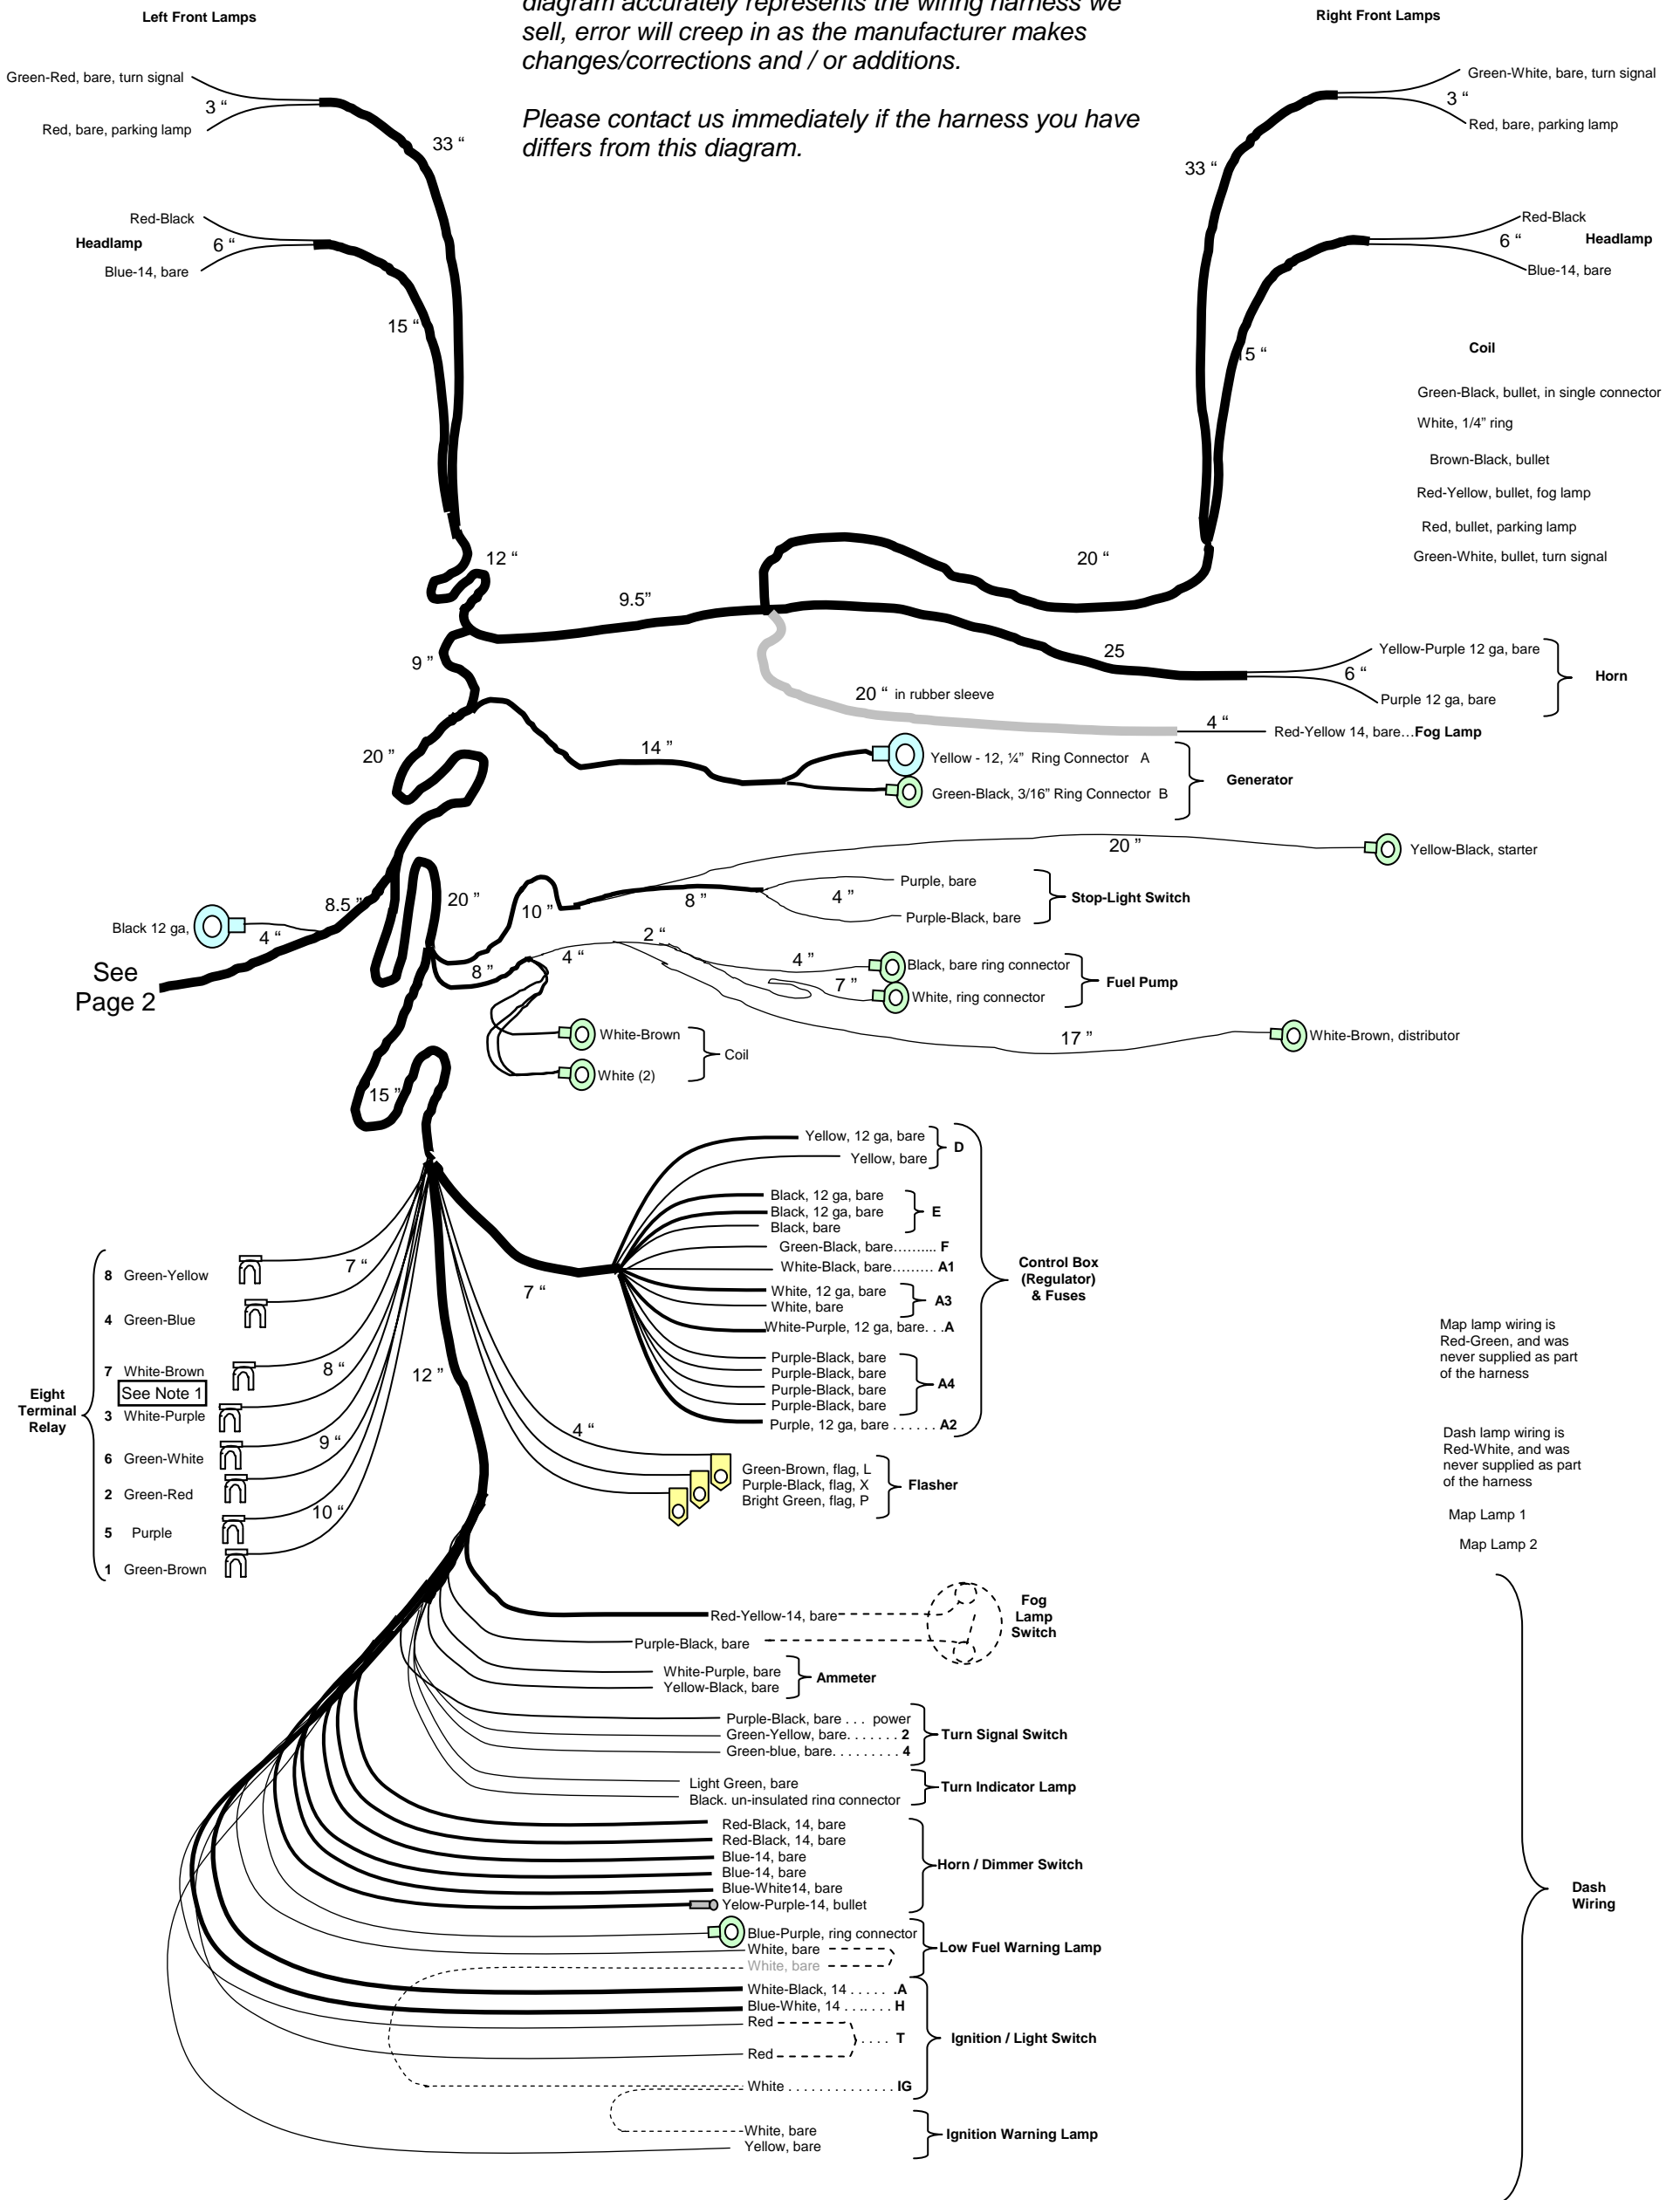
Page 1: Front Part of Harness

Although we have made every effort to ensure that this diagram accurately represents the wiring harness we sell, error will creep in as the manufacturer makes changes/corrections and / or additions.

Please contact us immediately if the harness you have differs from this diagram.

Note 1: the wiring diagram, which agrees with factory diagrams, shows White/Brown from the 8-Terminal relay box to the Right-hand side turn/brake bulb, and White/Purple to the left side. In at least one harness, these two wires were reversed - W/P went to the right side and W/B to the left side of the car. This was discovered this when the relay was wired as shown and opposite corners flashed when using the turn signals .
