## Fitting Instructions: Front Medallion

**Part Number:** 604272

**Description:** Front Medallion, Red/Black

**Applications:** Triumph TR3: 1955-57

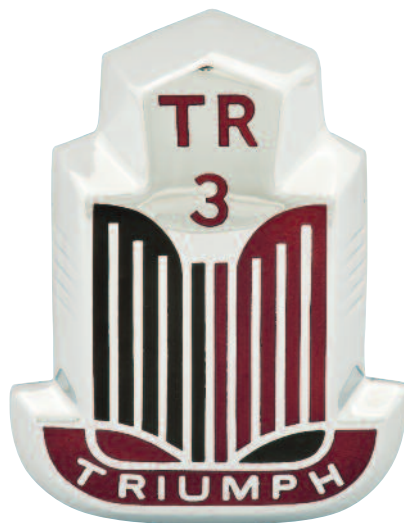
Due to the availability in reasonable quantities of the correct size material for the fixing peg the manufacturer has been forced to change the design to incorporate a threaded bar to fix this badge.

We have included a plastic nut which will act as a weak link to eliminate the risk of damage by overtightening if a steel nut was used therefore you must use the plastic nuts included with this badge, we also suggest that a little sealant is applied to the thread to stop the nut working loose.
