# Supplemental Information & Instructions for 839-128 Rocker Shaft w/Bushed Rocker Arms TR250, 5, 6 & GT6

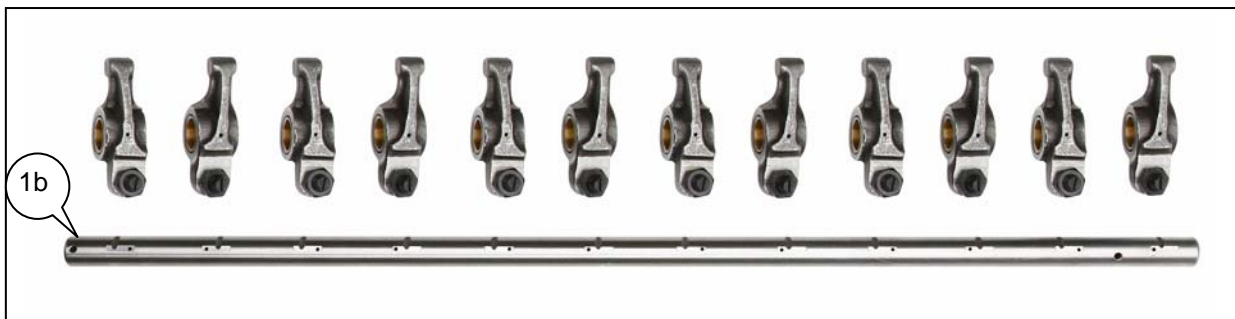
Moss decided to address these issues by arranging for special rocker arms to be made. These are identical to the OE rocker in shape, but are fitted with a bronze rocker arm bushing (1a). The challenge was figuring out how to deliver bushed rocker arms that would have the proper clearance when fitted to a new rocker shaft. We know that the optimum clearance between the bushing and the shaft is generally given as 0.002" to 0.003". Rocker shafts are made to a standard dimension, with some tolerance. That means the actual diameter of the shaft will vary a little bit. If we honed these rocker arms to fit a "standard" rocker shaft perfectly, they really would not be perfect when they were installed. The actual clearance would vary from shaft to shaft. That would be ok, but that was not what we were trying to achieve.

54 We send rocker shafts and rocker arms to Rocker Arm Specialists here in the US. They match a set of  
55 twelve bushed rocker arms - six 839-115 "odd" rocker arms (1c) and six 839-125 "even" rockers arms (1d)  
56 to a specific rocker shaft (1b) by honing the bushings to give a finished clearance of 2 thousandths  
57 (0.002"). Because we are matching rocker arms to a individual shaft, we don't have to compromise on the  
58 clearance to allow for variances in the actual diameter of different rocker shafts . We are holding a tighter  
59 tolerance to make sure that the rocker arm is always floating on an oil film. If you want to check the  
60 dimensions, be aware that you cannot accurately measure the ID of the bushing with callipers- you need  
61 an inside mic.
